Technical Bulletin

Marquee "Snap"

This bulletin explains how to correct an adjustment "snap" in Marquee projectors.

Applies to Marquee 8110, 8500, 8500LC, 9500LC with Control Module PCB#50-002036-03P manufactured before July 1997.

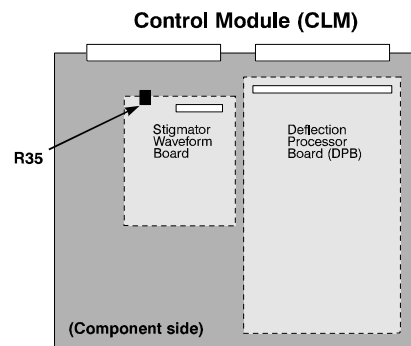
The "snap" problem occurs when a hardware adjustment seems incorrect and simply retrying the adjustment (with one touch of the key) makes the visible adjustment "snap" back to where it should be according to the slide bar's normal operation.

The most common snapping problems have occurred with Static Stigmation, Focus and HSIZE. The "snap" problem can conceivably occur on any adjustment controlled via a TDA8444 I²C device. These adjustments include:

On the Control Module PCB (50-002036-03P), change R35 from 470R SM to 3k3 SM (see right). This surface mount resistor is Electrohome part #70-733013-21P.
